*Journal of the Mechanical Behavior of Biomedical Materials* (2017)

# A large taper mismatch is one of the key factors behind high wear rates and failure at the taper junction of total hip replacements: A finite element wear analysis

## Abstract

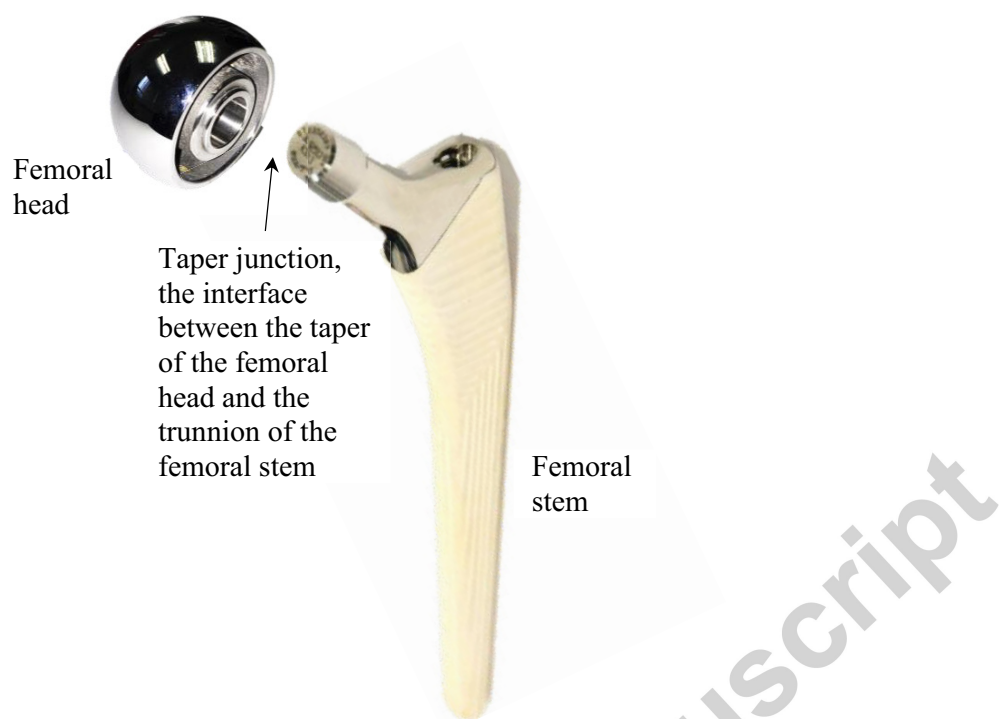
Figure 1: Ti Corail stem and CoCr femoral head

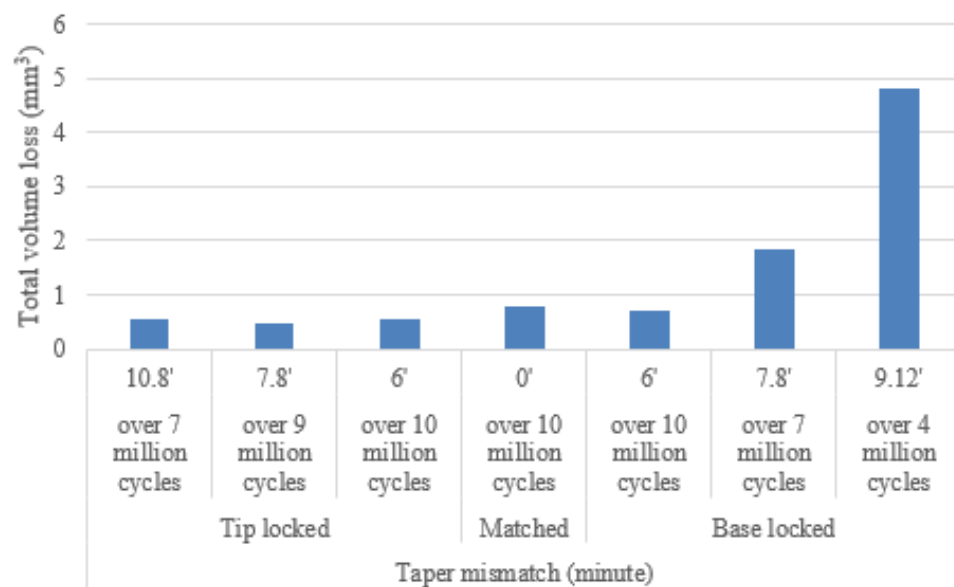
Figure 7: Total volume loss for different taper mismatches. Note that the total volume loss values presented are over different total number of load cycles.

Figure 7 shows the total volume loss after completion of the analyses comparing the perfectly matched analysis with base- and tip-locked taper mismatches. It should be noted that the total volume losses presented for different taper mismatches are over different load cycles. For example, over the period of 5 million loading cycles the total material loss for the 9.12° base-locked taper mismatch is 4.794 mm<sup>3</sup>. As the taper mismatch reduces, this total material loss is 1.858 and 0.693 mm<sup>3</sup> over 7 and 10 million loading cycles for the 7.8° and 6° cases respectively. Considering the perfectly matched model over the 10 million loading cycles, it can be seen that the total volumetric loss is slightly higher than the model with 6° taper mismatch with a value of 0.766 mm<sup>3</sup>. Figure 7 shows relatively lower total material loss over time for the tip-locked cases, while this value was obtained over a shorter area of contact with the destructive wear damage shown in Figure 5.
